MECHANISTIC STUDIES OF STRESS
CORROSION CRACKING IN AUSTENITIC
STAINLESS STEELS AND IN 70CU-30ZN

XIAOZHU WU
DÉPARTEMENT DE GÉNIE PHYSIQUE
ET DE GÉNIE DES MATÉRIAUX
ÉCOLE POLYTECHNIQUE DE MONTRÉAL

THÈSE PRÉSENTÉE EN VUE DE L'OBTENTION
DU DIPLÔME DE PHILOSOPHIAE DOCTOR (Ph.D.)
(GÉNIE MÉTALLURGIQUE)

JUILLET 1998

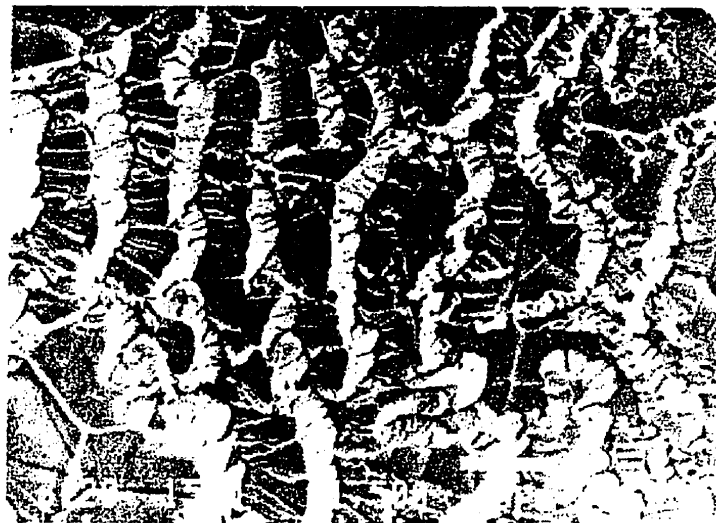
Figure 3.3 Transgranular SCC fracture in the δ -ferrite is present among interfacial cracking in ST orientated specimens of 316L stainless steel. The transgranular fracture often shows such regular hills and valleys between the ferrite-austenite interfaces.

lines propagated back to meet the main PSSC crack. Pronounced striations were essentially perpendicular to the river lines and interlocked with each other on opposite surfaces. Comparing Fig. 3.5a with Fig. 3.3, it can be seen that transgranular PSSC fracture is considerably different from transgranular SCC in the δ -ferrite, which occurs along planes inclined approximately 45° to the tensile axis and goes back and forth between the γ - δ interfaces in ST orientated specimens.

planes inclined approximately 45° to the tensile axis (Fig. 3.3), is also in agreement with the slip and cross slip of screw dislocations on these primary planes. Because the primary $\{110\}$ planes make an angle of approximately 45° to the tensile axis and to the macroscopic SCC crack front in δ -ferrite, they are situated in the most favored position for dislocation movement under the maximum shear stress in the plane strain region. The screw dislocations emitted from the crack tip on those planes create a Mode III deformation at the macroscopic crack front. Therefore, the local propagation directions observed often make a large angle the macroscopic crack propagation direction. Cross slip combined with decohesion on the primary $\{110\}$ planes produce both microfacets and incompatible deformation on interfaces. The latter may induce interfacial cracking (Fig.3.3) to relieve the strain before new transgranular crack is initiated on another primary $\{110\}$ plane. It is also possible that several primary $\{110\}$ planes form simultaneously at the main crack front then link together by short interfacial cracking. In either case, cross slip occurs separately on each primary plane and interfaces act as sinks to absorb dislocations. Since hydrogen inhibits the annihilation of screw dislocations with different Burger vectors [211], serrations on river lines could be formed by cross slip and by decohesion of dislocations with Burgers vectors different from those which produce the larger microfacets.

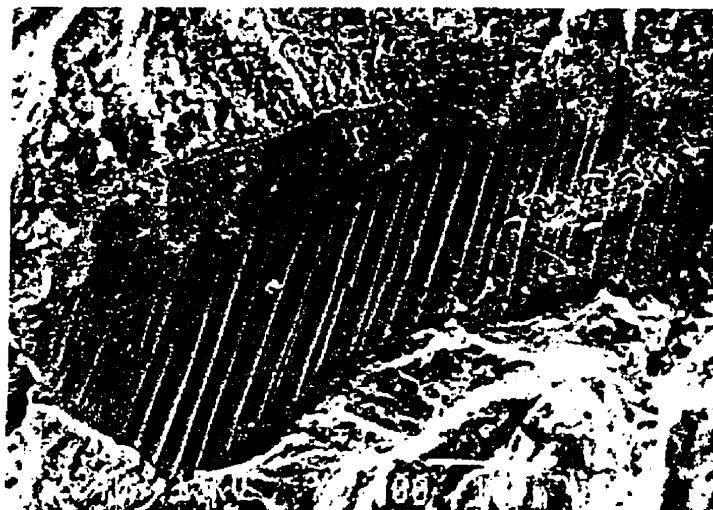
Figure 3.13 A large facet formed during fatigue after SCC in 316L stainless steel. The slip lines indicate that this is a $\{111\}$ slip plane.

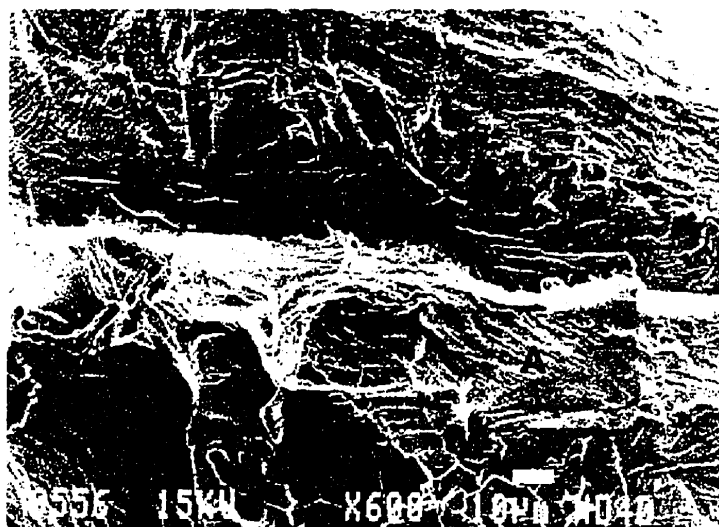
Figure 3.17 Transgranular fractured δ -ferrite (F) is separated by a transition stretch zone in austenite (A) in the hydrogen-induced cracking zone, in the same specimen as Fig. 3.15.

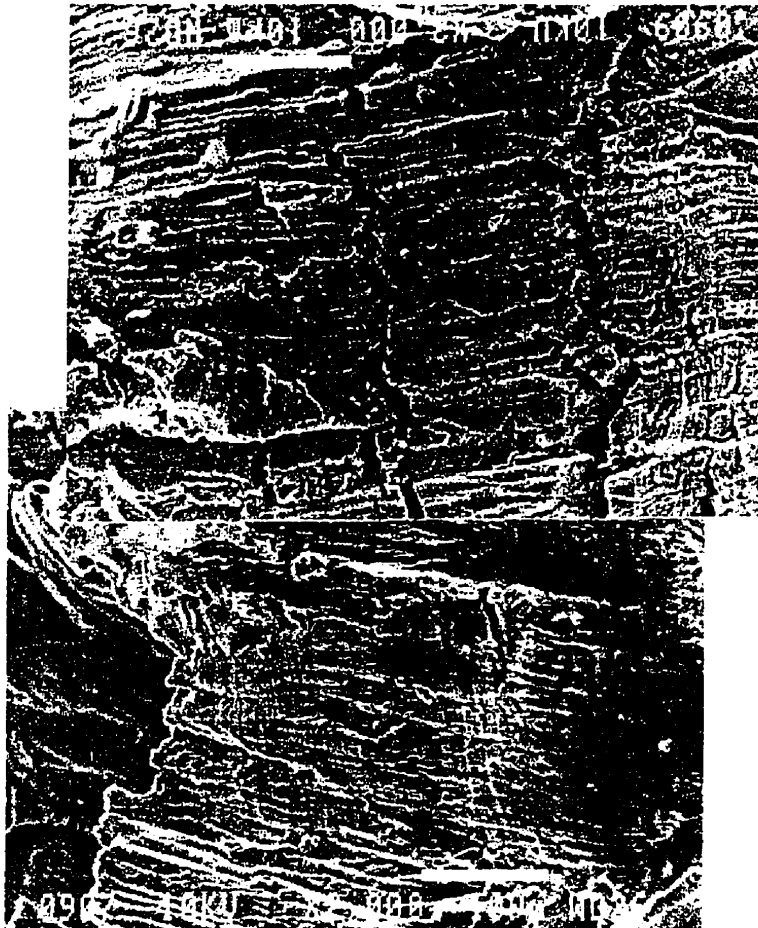
Figure 3.20 Striations on matching fracture surfaces produced at a slow COD opening rate in MgCl_2 solution in a 310 stainless steel specimen. Not all the striations, such as in regions A and A', are matching on the opposite fracture surfaces.

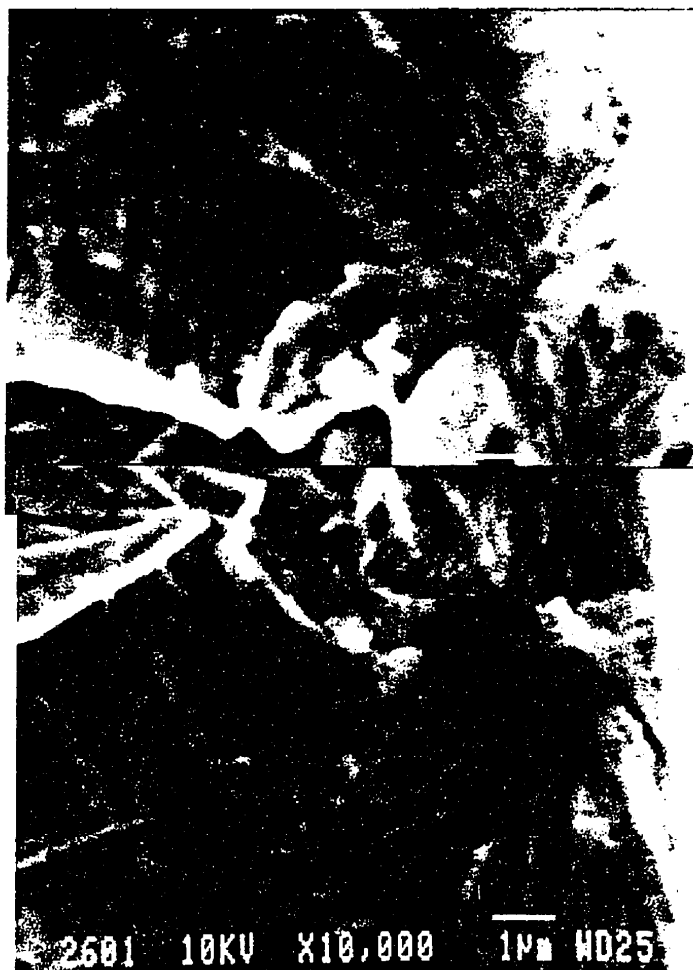
Figure 3.23 Crystallographic cracking in a non-annealed ribbons immersed in 154°C MgCl_2 solution without stress. The cracking is initiated at A between the surface SCC fracture and final ductile fracture. The microfacets in this region are very small and interlock (such as those indicated by arrows) on opposite fracture surfaces.

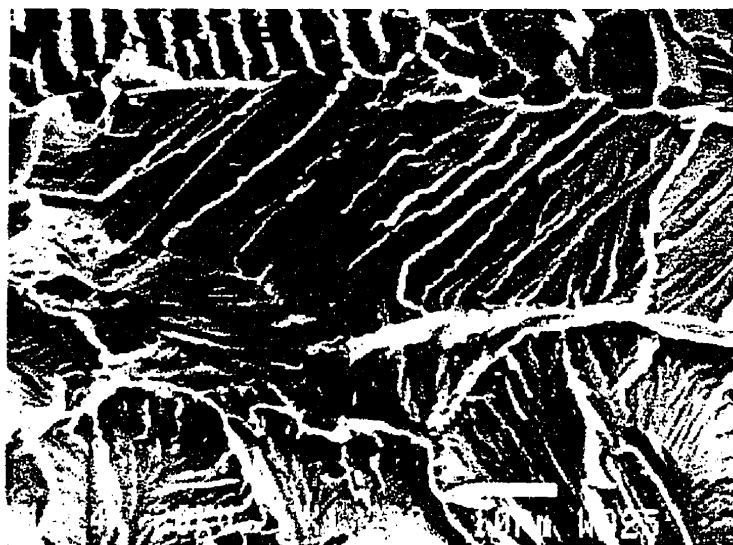
Figure 4.2 SCC fracture in austenite (A) was initiated from the δ -ferrite (F) ahead of the main crack and linked up with the main crack at the tearing ridge. The macroscopic propagation direction is from the bottom to the top.

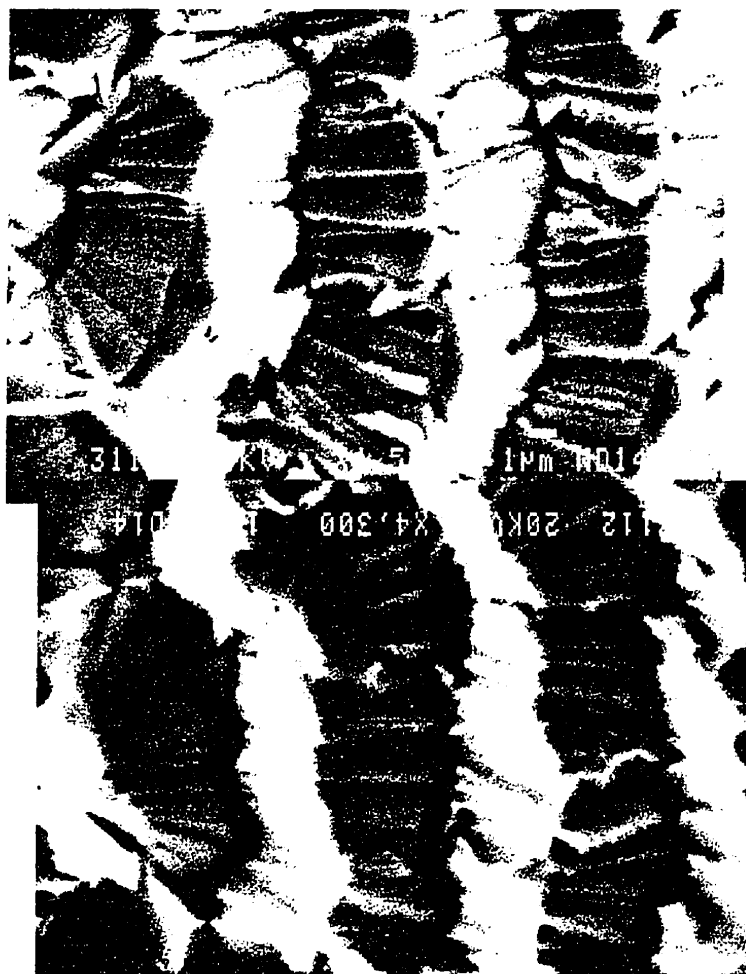
Figure 4.3 Matching fractographs of transgranular fracture in δ -ferrite. Cracks initiate at the interface between δ -ferrite and austenite and propagate on inclined facets.

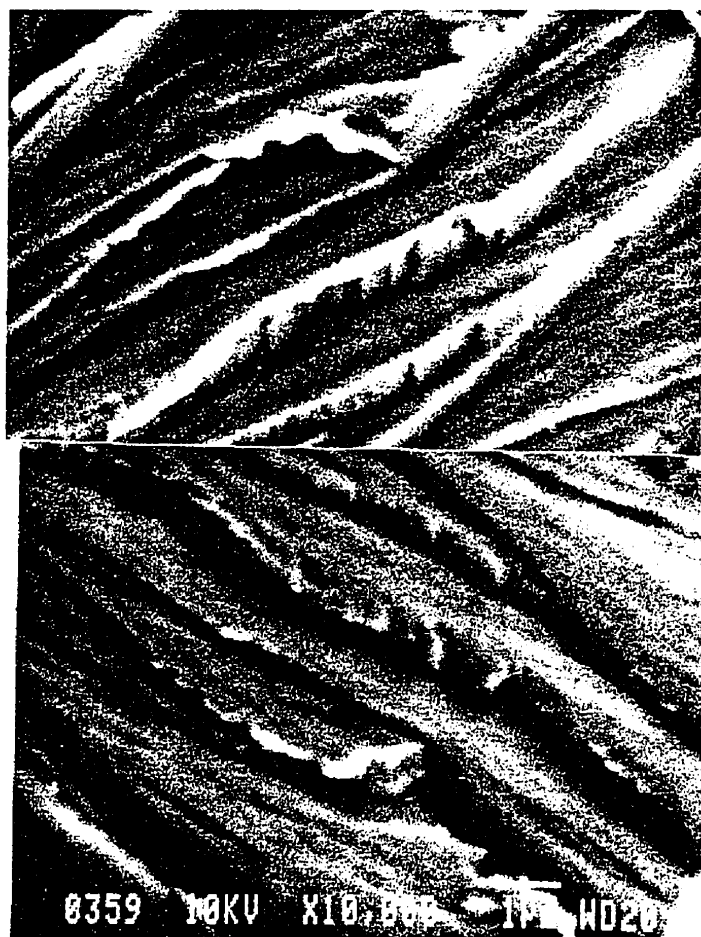
Figure 4.6 Matching fractographs of transgranular fracture in the δ -ferrite. Fine river lines are parallel to coarse river lines.

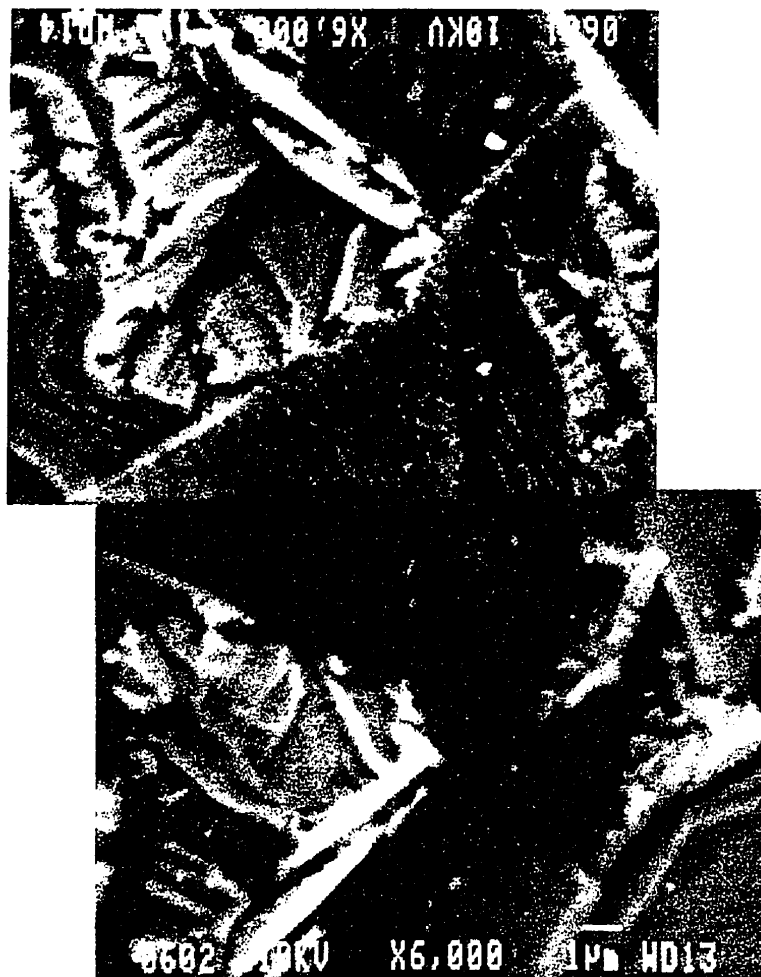
Figure 4.8 Matching fractographs of SCC fracture surfaces. Arrest lines appear on the interfacial boundary of the δ -ferrite side and match on the transgranular facets on both sides in the δ -ferrite.

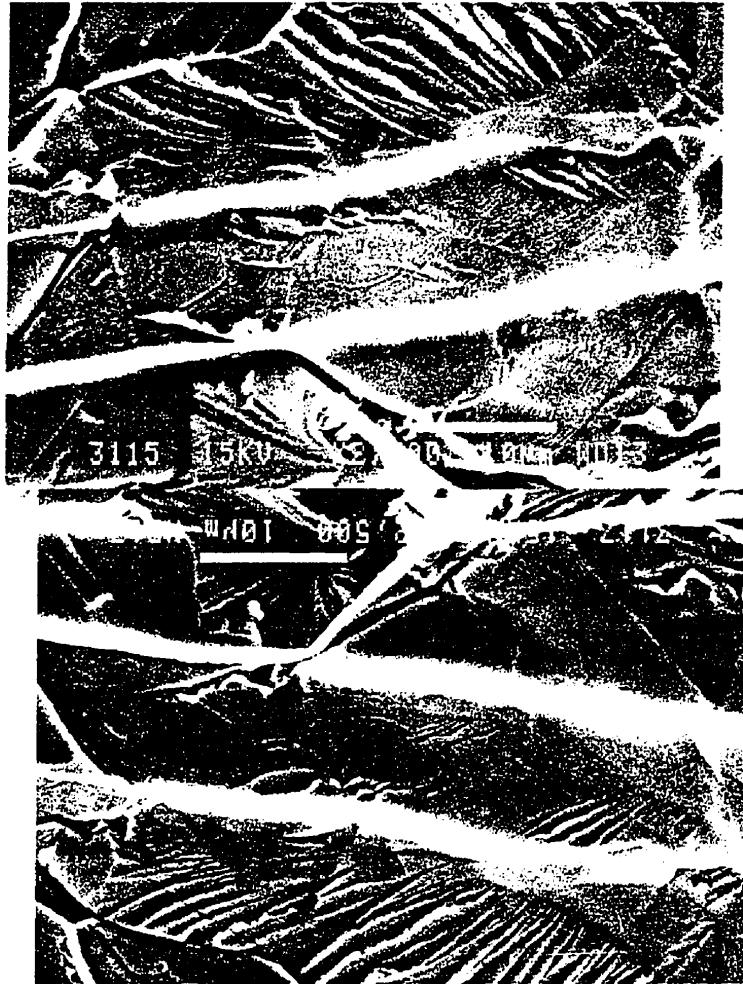
Figure 4.10 Matching fractographs of an interfacial SCC fracture. Several initiation sites ahead of the SCC crack tip are indicated by crack arrest lines which interlock on opposite fracture surfaces.

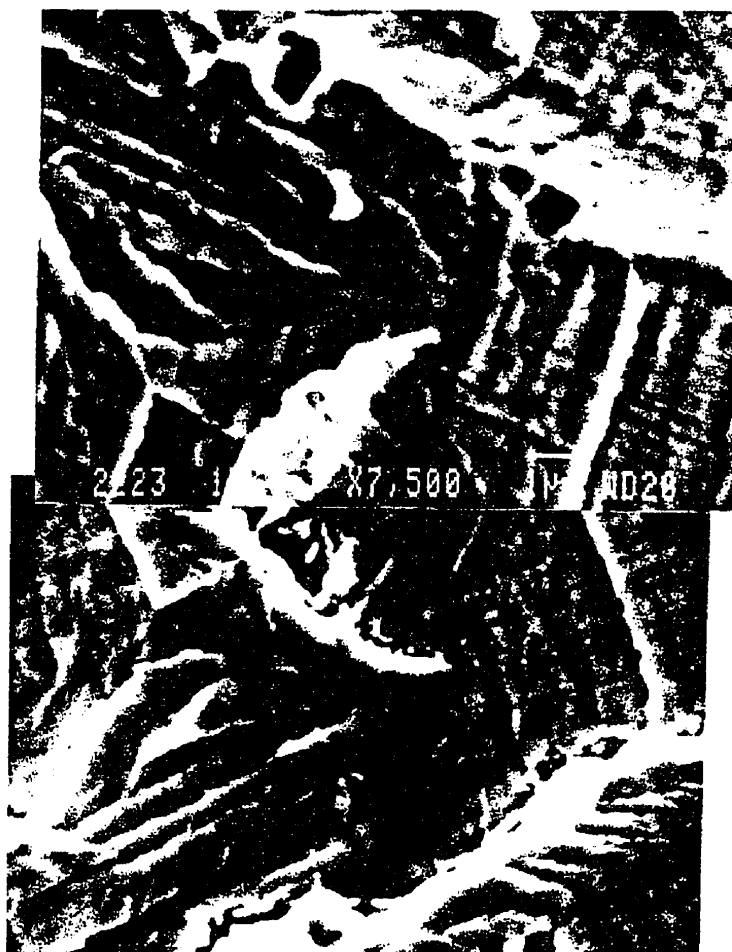
Figure 5.4 Matching fractographs of the PSCT crystallographic fracture in the δ -ferrite.

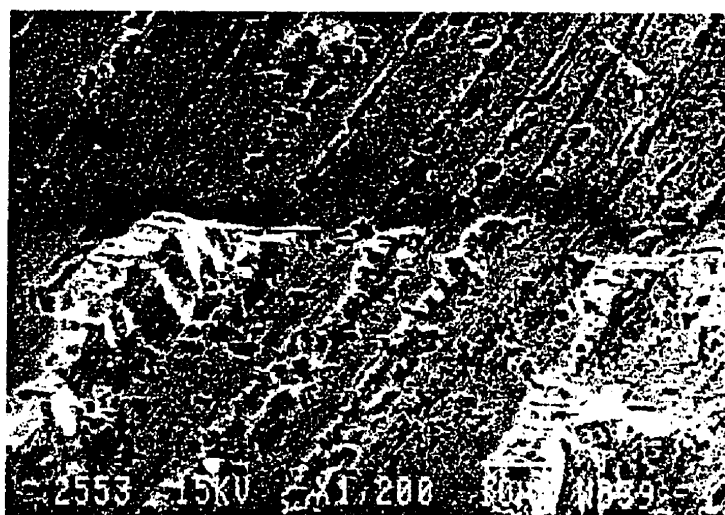
Figure 6.2 Preferential dissolution occurs on grain boundaries along slip lines during SCC in annealed 70Cu-30Zn, which also corresponds to the regions of transgranular SCC cracking.

The intergranular fracture generally presented smooth grain boundaries, but some small protrusions appeared, especially near the transgranular regions and for those specimens further protected by glass and silicon sealant on the surfaces. Fig. 6.1 is an example of such quasi-intergranular fractures. The slip lines and corrosion pits on the grain boundary indicate this boundary is almost parallel to $\{100\}$ in one grain. Dissolution slots were observed along slip lines on grain boundaries. These preferential sites coincided with the slip system where the local transgranular cracking formed (Fig. 6.2).

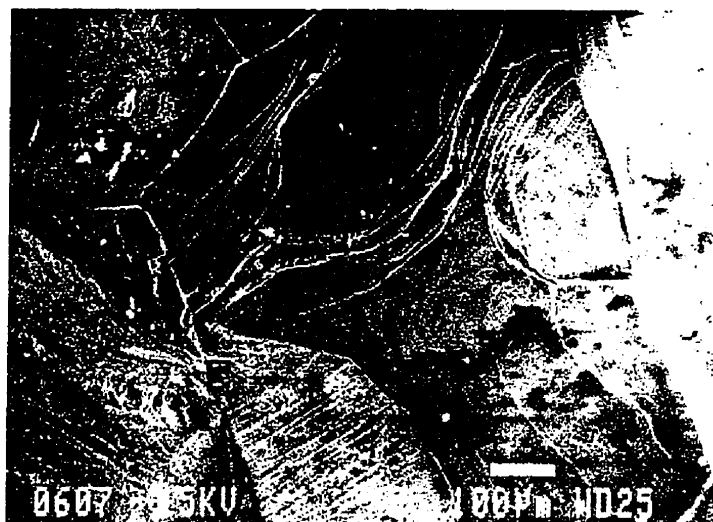
Figure 6.6 Large crystallographic facets observed in SCC of annealed 70Cu-30Zn. These facets are approximately perpendicular to the tensile axis and are linked by steps initiated from grain boundaries. Corrosion pits on the facets indicate the {111} orientation of the facets.

Occasionally, large crystallographic planes approximately perpendicular to the tensile axis were found in some isolated grains. These facets were quite large and layered together in one grain. The orientation of the large facets shown in Fig. 6.6 was determined as $\{111\}$ with the help of corrosion pits in this region by stereomicroscopy. There were some transgranular regions attached on those large facets. The steps linking parallel $\{111\}$ planes were perpendicular to $\{111\}$ planes. These steps often initiated from grain boundaries and coarsened towards the center of the grain, resembling those steps in the twin of Fig. 6.4b. Very probably, the facets connected by crystallographic steps in the twin of Fig. 6.4b are also $\{111\}$.

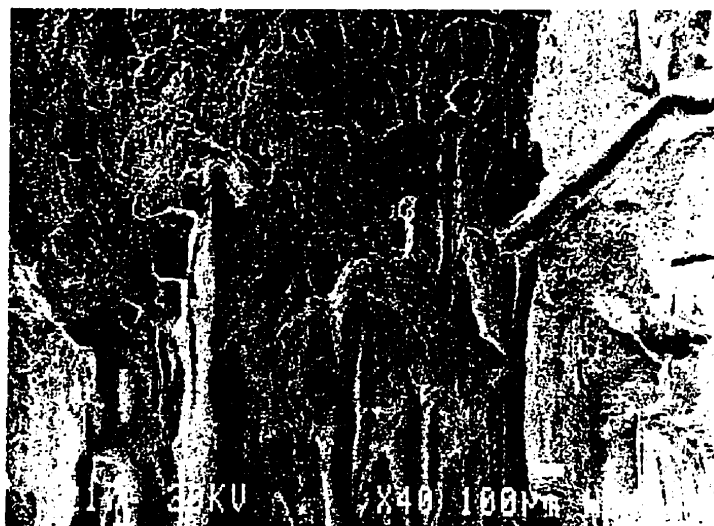
Figure 6.13 Intergranular SCC crack front in a cold rolled specimen with 70% reduction in thickness. Second cracks perpendicular to the average cracking plane lead the average crack front near the lateral surfaces and in the central region.

The SCC crack front in the specimen with 70% reduction in thickness was very irregular. The crack propagation was fast near the lateral surfaces and along elongated grain boundaries (Fig. 6.13). Most of these leading intergranular cracks were secondary cracks which presented rough grain boundaries. The whole fracture surface was separated vertically by these secondary cracks into several portions which were not coplanar but all were perpendicular to the tensile axis. Such a fracture surface indicates that the transgranular propagation was relatively independent in each portion after initiating from the intergranular fracture. The crack front was quite straight in the specimen reduced 50%

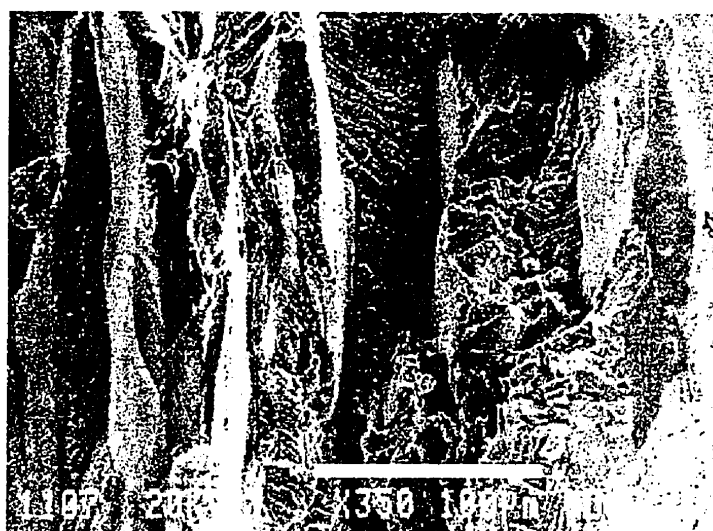
Figure 6.14 Transgranular fracture initiates at the grain boundaries which are parallel to the rolling plane in cold worked specimens. The local propagation directions in the transgranular region make angles either $\sim 45^\circ$ or $\sim 90^\circ$ to the macroscopic propagation direction.

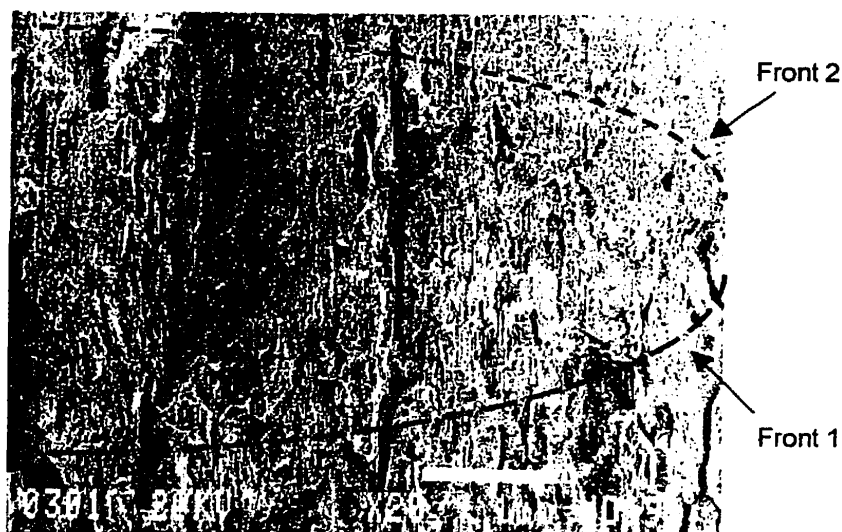
Figure 6.16 The SCC crack front in a cold worked CT specimen. (a) Schematic illustration of the final part of SCC fracture. (b) The corresponding fracture surface.

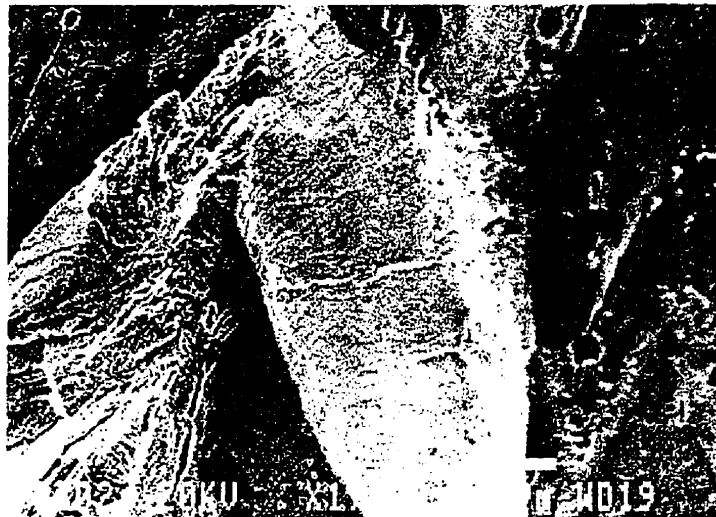
Figure 6.18 Slip steps on the grain boundary of cold worked CT specimen.

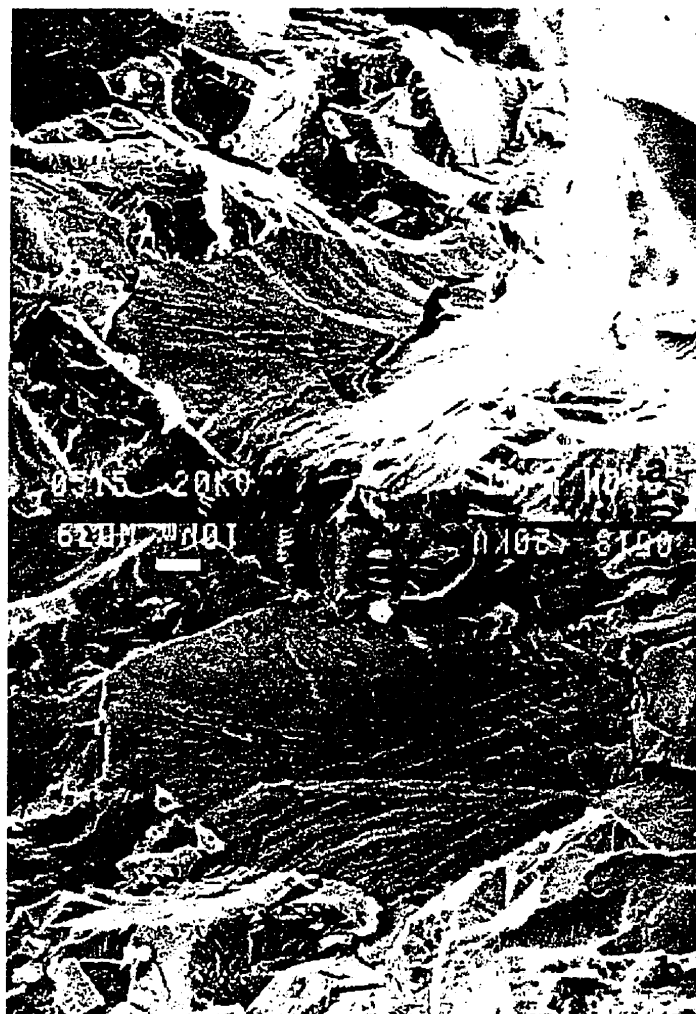
Figure 7.3 Matching fractographs show crack front markings in 310. The inclination is interlocked on opposite fracture surfaces but slightly in (b).

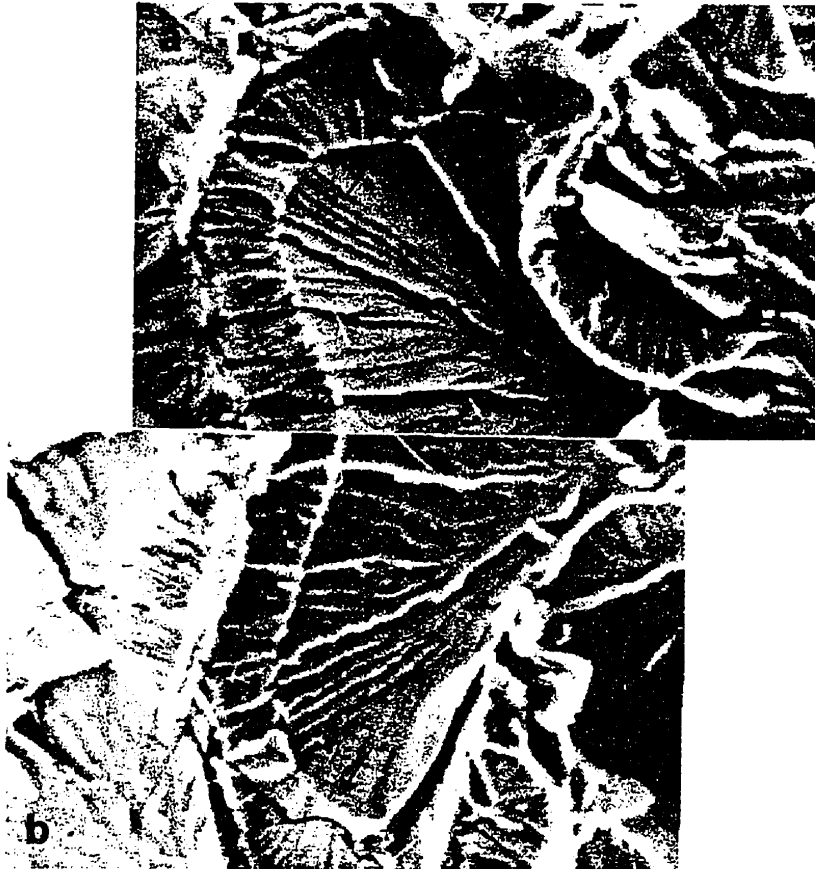
Figure 7.4 A matching pulse trace in 310 stainless steel on a $\{100\}$ primary facet. Arrows indicate the local corresponding step and blunting produced by the load pulse. The straight crack fronts are perpendicular to $\langle 110 \rangle$. The step in (b) indicated by an arrow is identified as $\{110\}$ since it is perpendicular to $\{100\}$ and to $\langle 110 \rangle$.

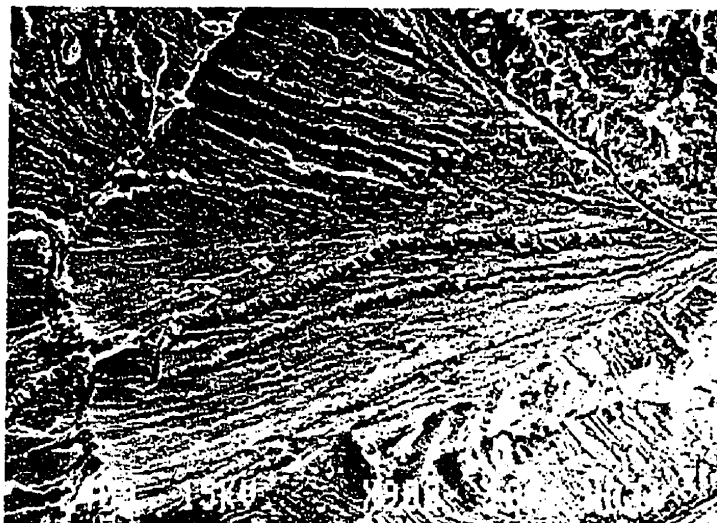
Figure 7.5 A crack front marking composed of two straight segments in 70Cu-30Zn.

The crack front defined by the load pulse traces is crystallographic. In 70Cu-30Zn, the large grain size allowed the crack front to be straight and parallel to striations along a certain distance (Fig. 7.5). Straight crack fronts were also found in 310 stainless steel when the crack propagated along $\{100\}\langle 110\rangle$ (Fig. 7.4). The crack front was then parallel to striations and curved to link straight segments, where the two cracking planes were joined by forming larger rivers. This indicates that the crack propagation follows $\{111\}$ planes because the striations during SCC of fcc materials are the intersection of two $\{111\}$ planes [2].

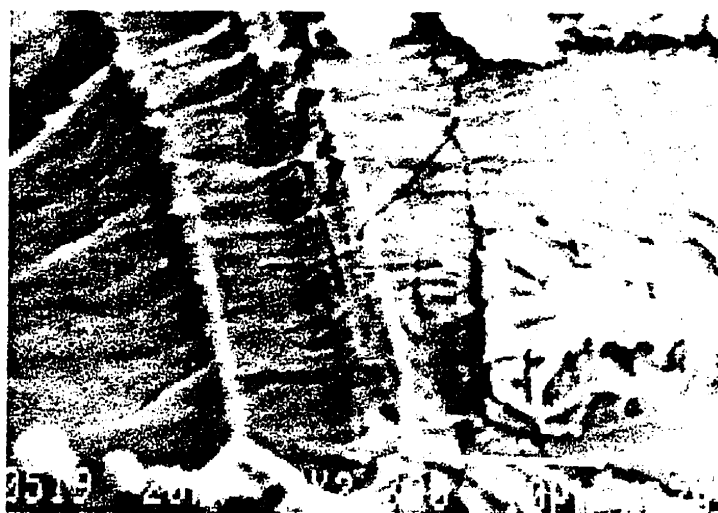
Figure 7.6 A large step, composed of several tiny steps, produced by a load pulse in 310 stainless steel.

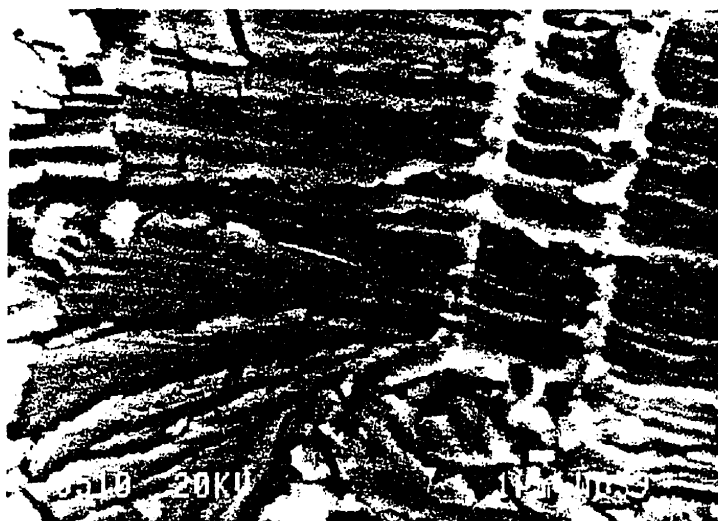
Figure 7.7 Two crack front markings produced by load pulses in 310 stainless steel. The blunting appears to be made up of tiny steps.

to striations. In the easy propagation direction $\langle 110 \rangle$, load pulse deviated the $\{100\}$ plane from its original orientation to form a $\{110\}$ step on one side (Fig. 7.4). The following propagation occurred on an inclined $\{100\}$ plane on the other side after a very small blunting. When the steps became larger, it made up of several tiny steps (Fig. 7.6). The observed blunting at the pulse traces actually corresponded to several tiny steps at the corner (Fig. 7.7).

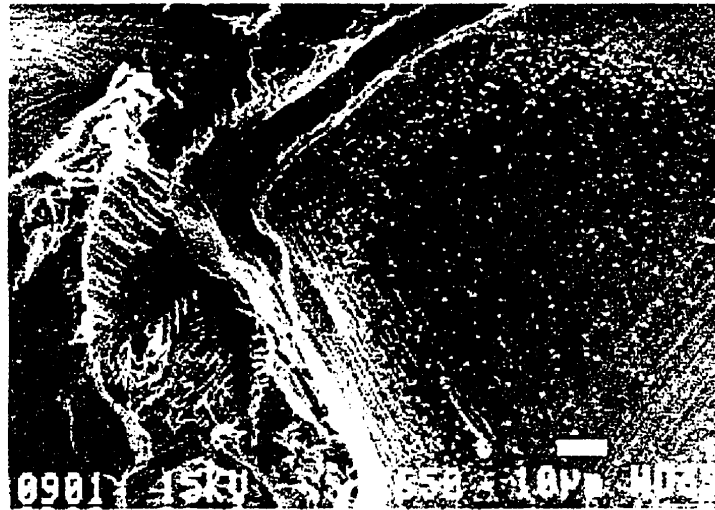
Figure 7.10 Crack front markings on a grain boundary of 70Cu-30Zn.

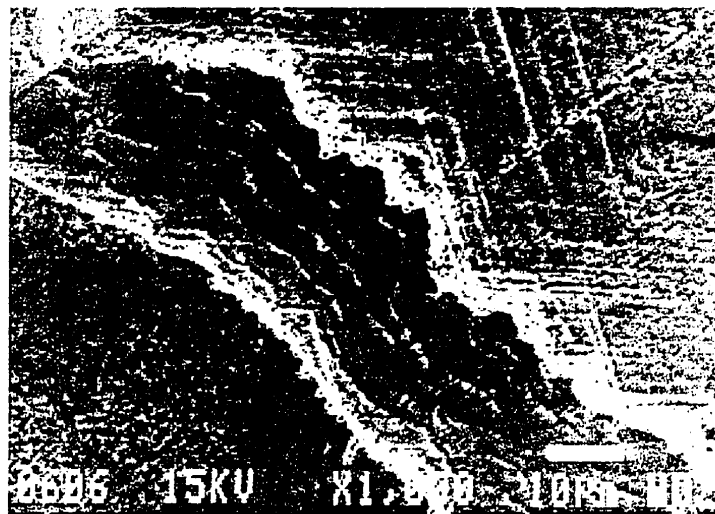
Figure 7.11 Curved crack front markings on a grain boundary of 70Cu-30Zn, which locally follow two sets of slip lines.

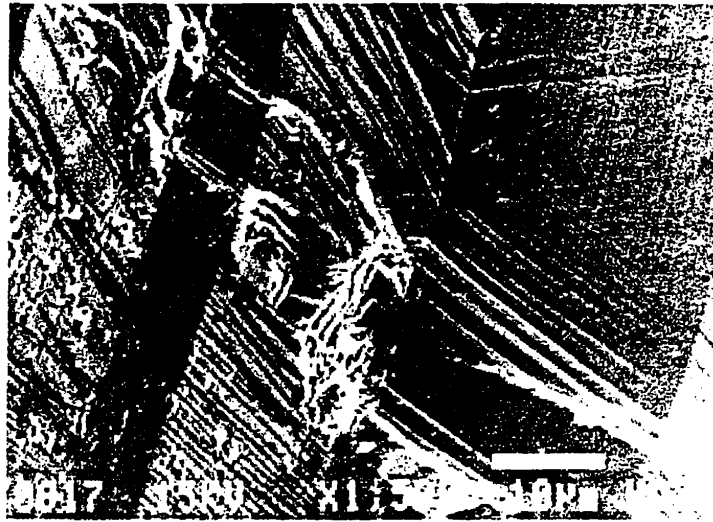
Figure 7.12 Two intergranular crack front markings are parallel to crystallographic orientations in twins and slip steps on the grain boundary.

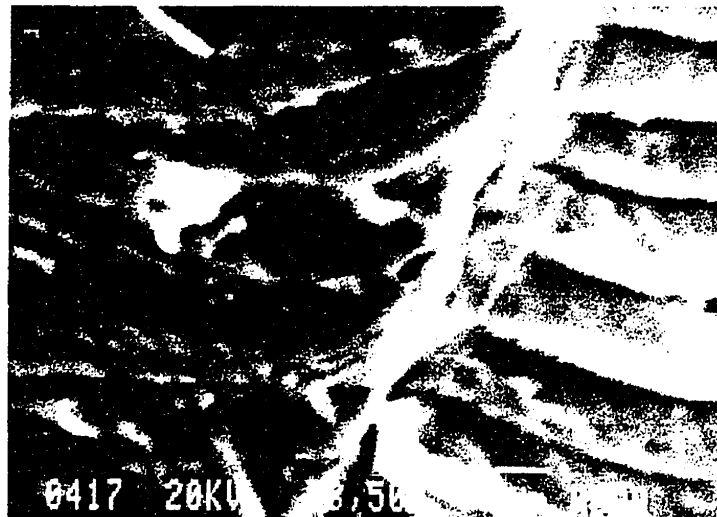
Figure 7.13 Cracking reinitiates at the crack tip after a load pulse in 70Cu-30Zn.

Since the crack “blunting” made by load pulses were very small and crystallographic, the crack reinitiation sites were all very close to the crack front markings. The closest position in 70Cu-30Zn was just at the markings (Fig. 7.13). In 310 stainless steel, the crack front markings were usually not as sharp as those in 70Cu-30Zn. Some reinitiation sites were observed approximately 1 μm ahead of markings (Fig. 7.14). In these cases, however, no inverse propagation was observed. The position of reinitiation site agrees with the mechanisms proposed here for SCC: adsorption is very important in the SCC of 70Cu-30Zn while absorbed hydrogen is involved in that of austenitic stainless steels.

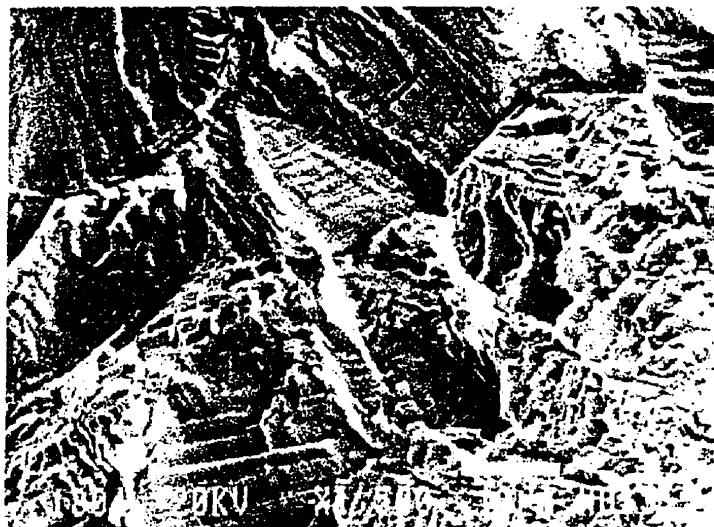
Figure 7.15 Large microfacets ahead of a crack front marking in 310 stainless steel. Two sets of $\{111\}$ facets meet along a $\langle 110 \rangle$ and the third set intersects these as striation markings. In the lower right corner of the photograph, four sets of $\{111\}$ facets are present.

Transgranular SCC propagation after the load pulses tended to present complex features. The higher load resulted in larger microfacets produced ahead of crack front markings. As shown in Fig. 7.15, two $\{111\}$ planes which compose the $\{100\}$ primary facet become approximately 2 μm in width and another set of $\{111\}$ facets appears ahead of the crack front markings. A little further the crack front marking, four sets of $\{111\}$ planes are all operating. The high K features were more evident in 70Cu-30Zn where the primary facets were usually larger than in 310 stainless steel. The complexity appears for about 30 μm ahead of the crack front markings in Fig. 7.16, then the propagation returns

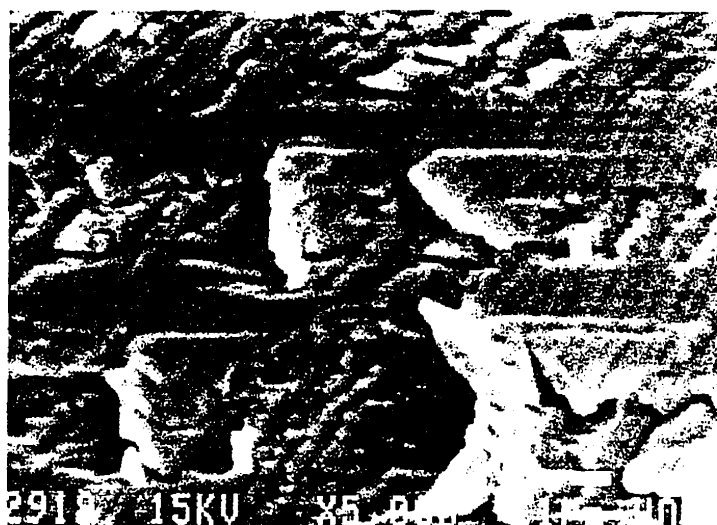
Figure 7.17 The quasi-intergranular fracture in a load pulse region of 70Cu-30Zn. It produced by the local crack branching into the grain boundary.
